**EFFECTS OF TEMPERATURE AND STEAM ENVIRONMENT ON FATIGUE
BEHAVIOR OF THREE SIC/SIC CERAMIC MATRIX COMPOSITES**

THESIS

Vipul Sharma, 2nd Lieutenant, USAF

AFIT/GAE/ENY/08-S02

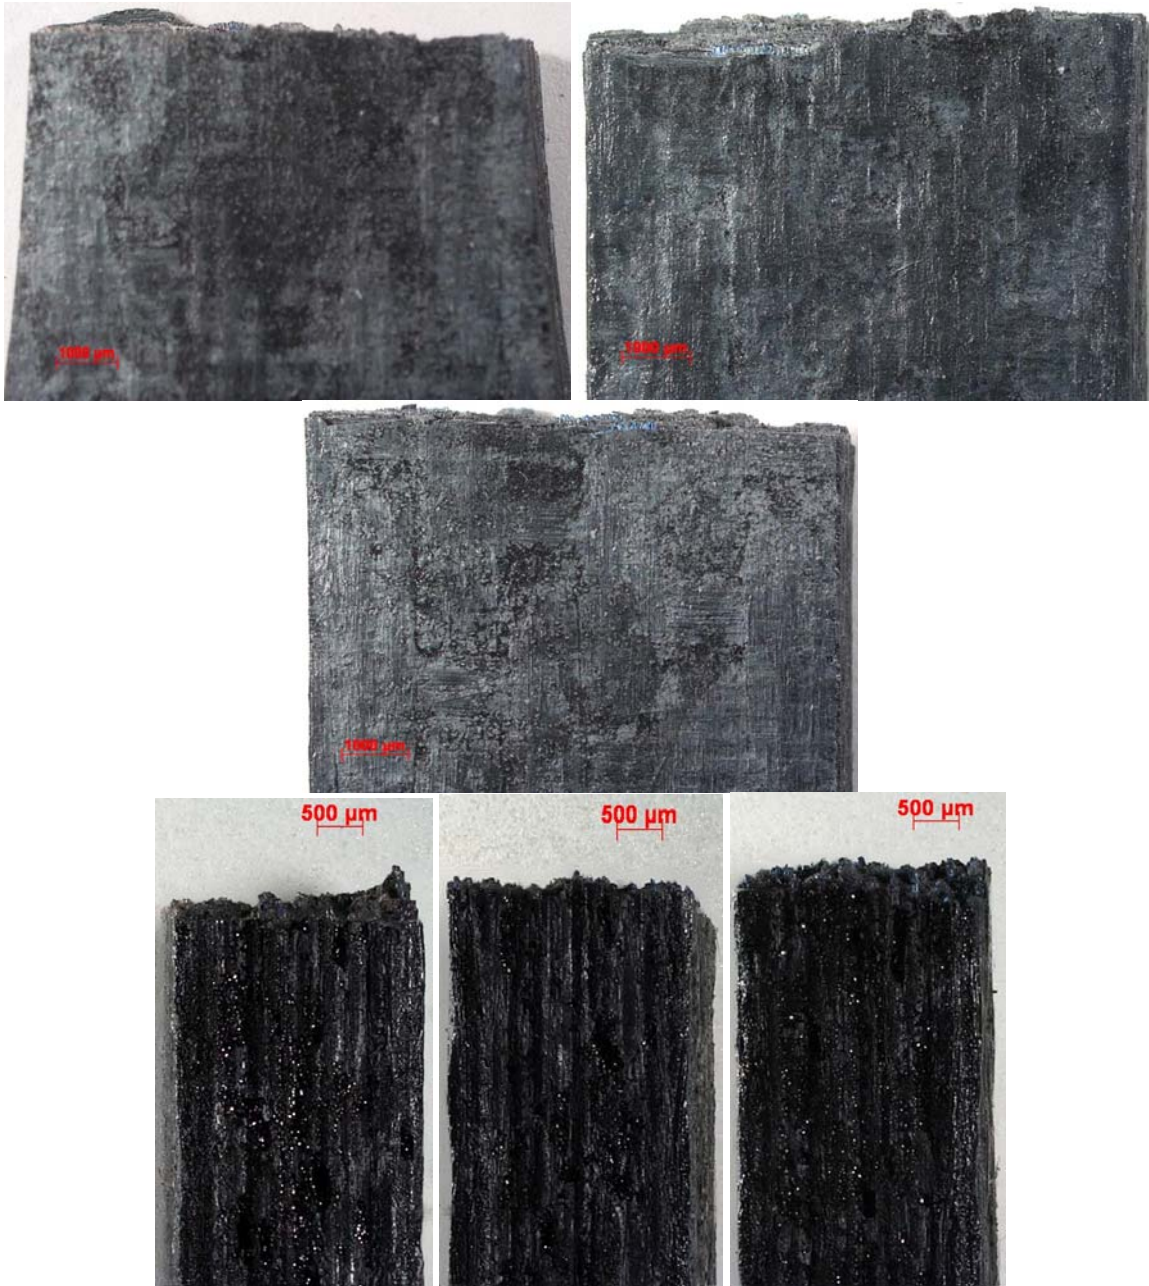
Figure 69. Fracture surface optical micrographs of composite C1 specimen fatigued in air at 1300 °C with maximum fatigue stress $\sigma_{\max} = 100$ MPa

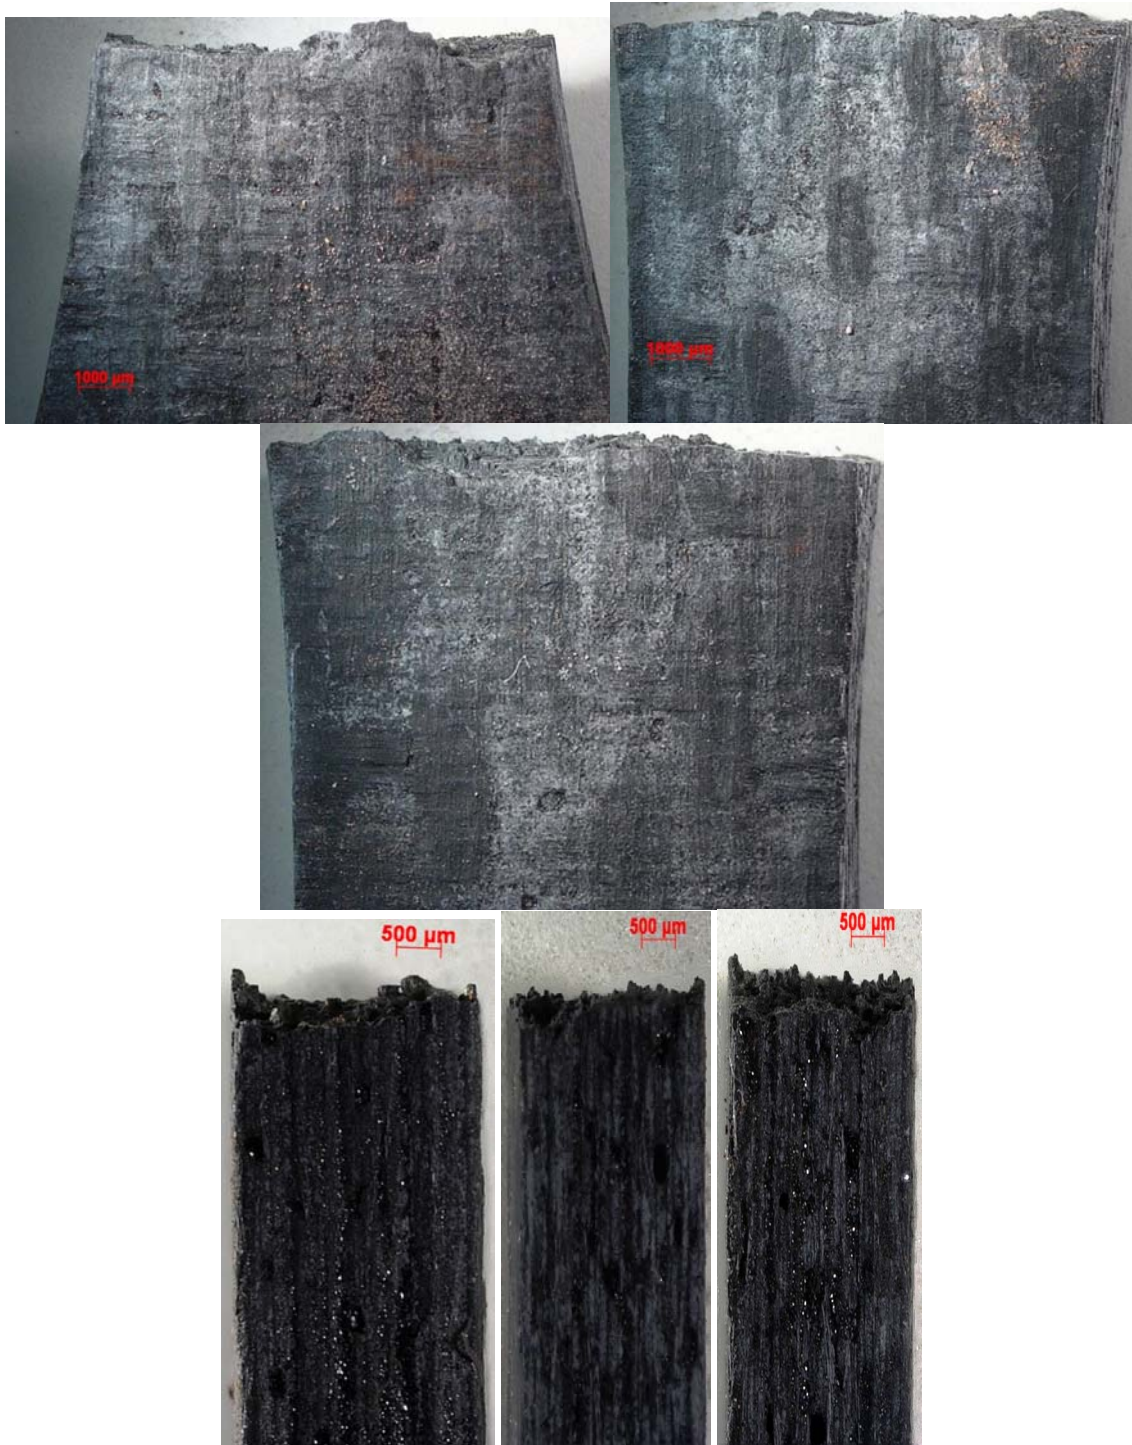
Figure 73. Fracture surface optical micrographs of composite C1 specimen fatigued in steam at 1300 °C with maximum fatigue stress $\sigma_{\max} = 120$ MPa

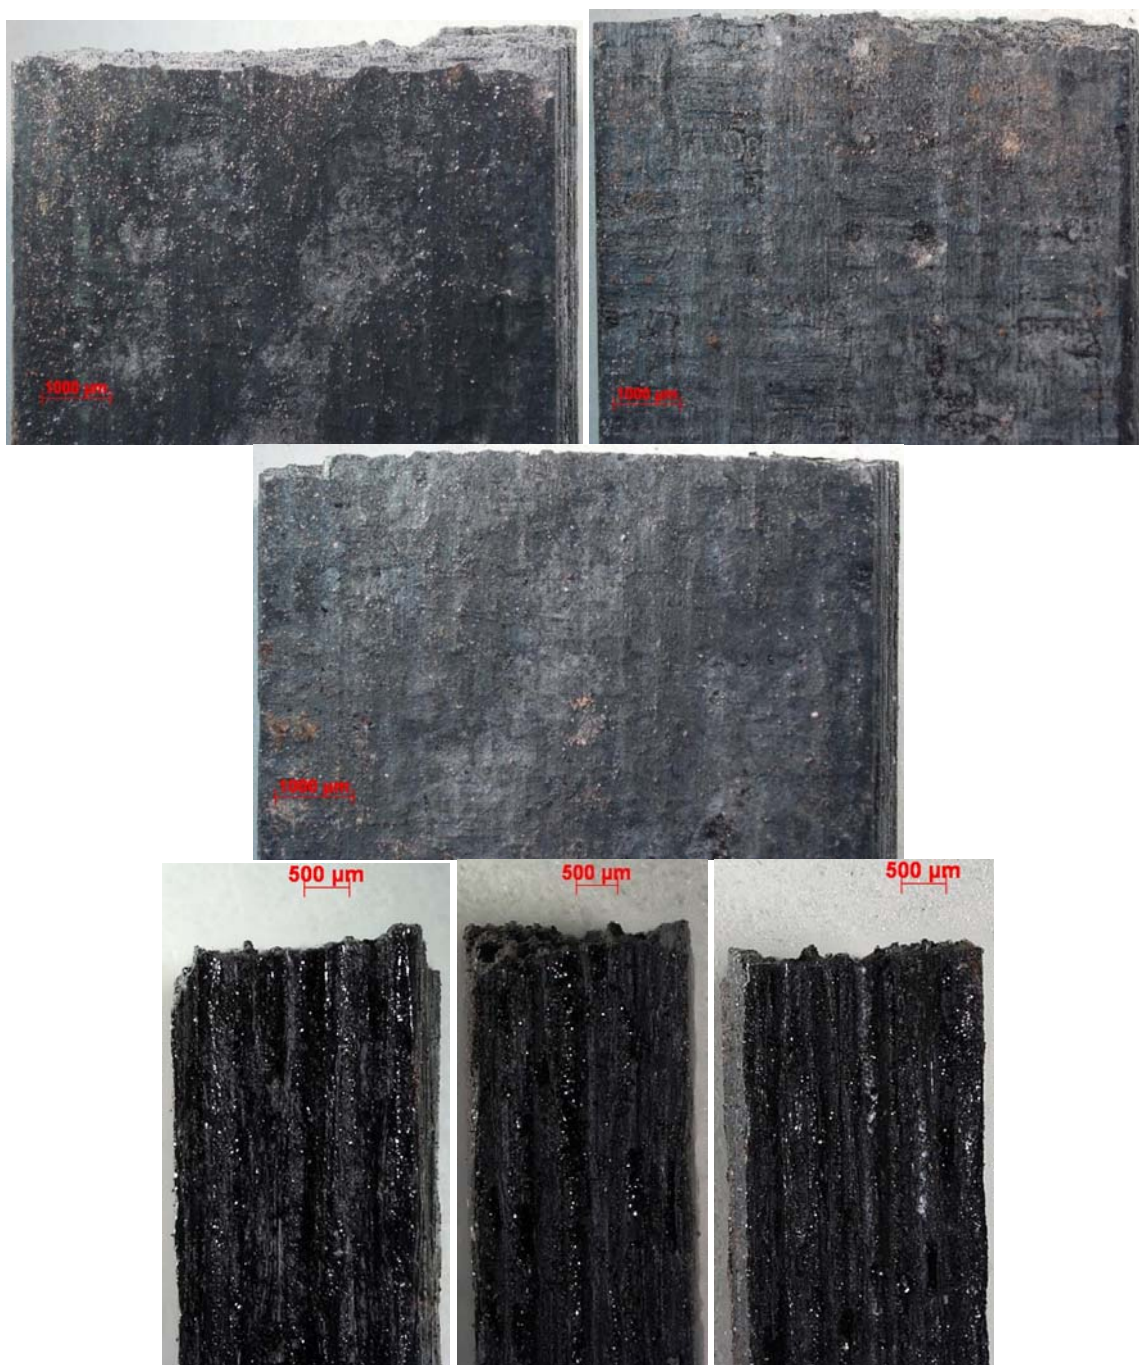
Figure 74. Fracture surface optical micrographs of composite C1 specimen fatigued in steam at 1300 °C with maximum fatigue stress $\sigma_{\max} = 140$ MPa

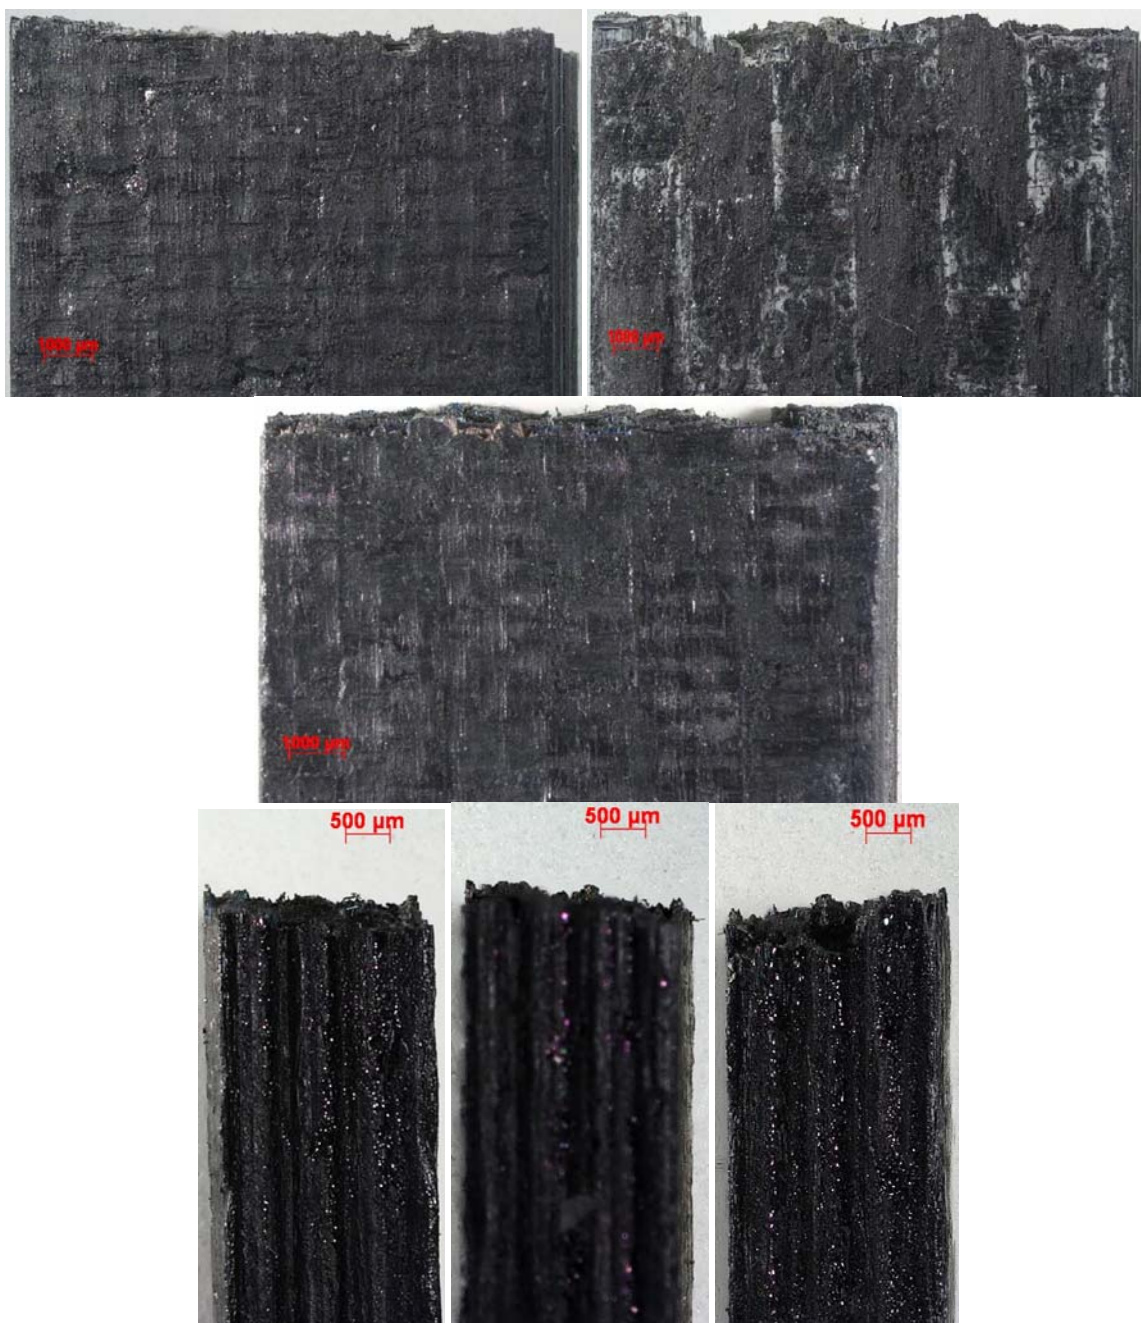
Figure 76. Fracture surface optical micrographs of composite C2 specimen fatigued in air at 1300 °C with maximum fatigue stress $\sigma_{\max} = 140$ MPa

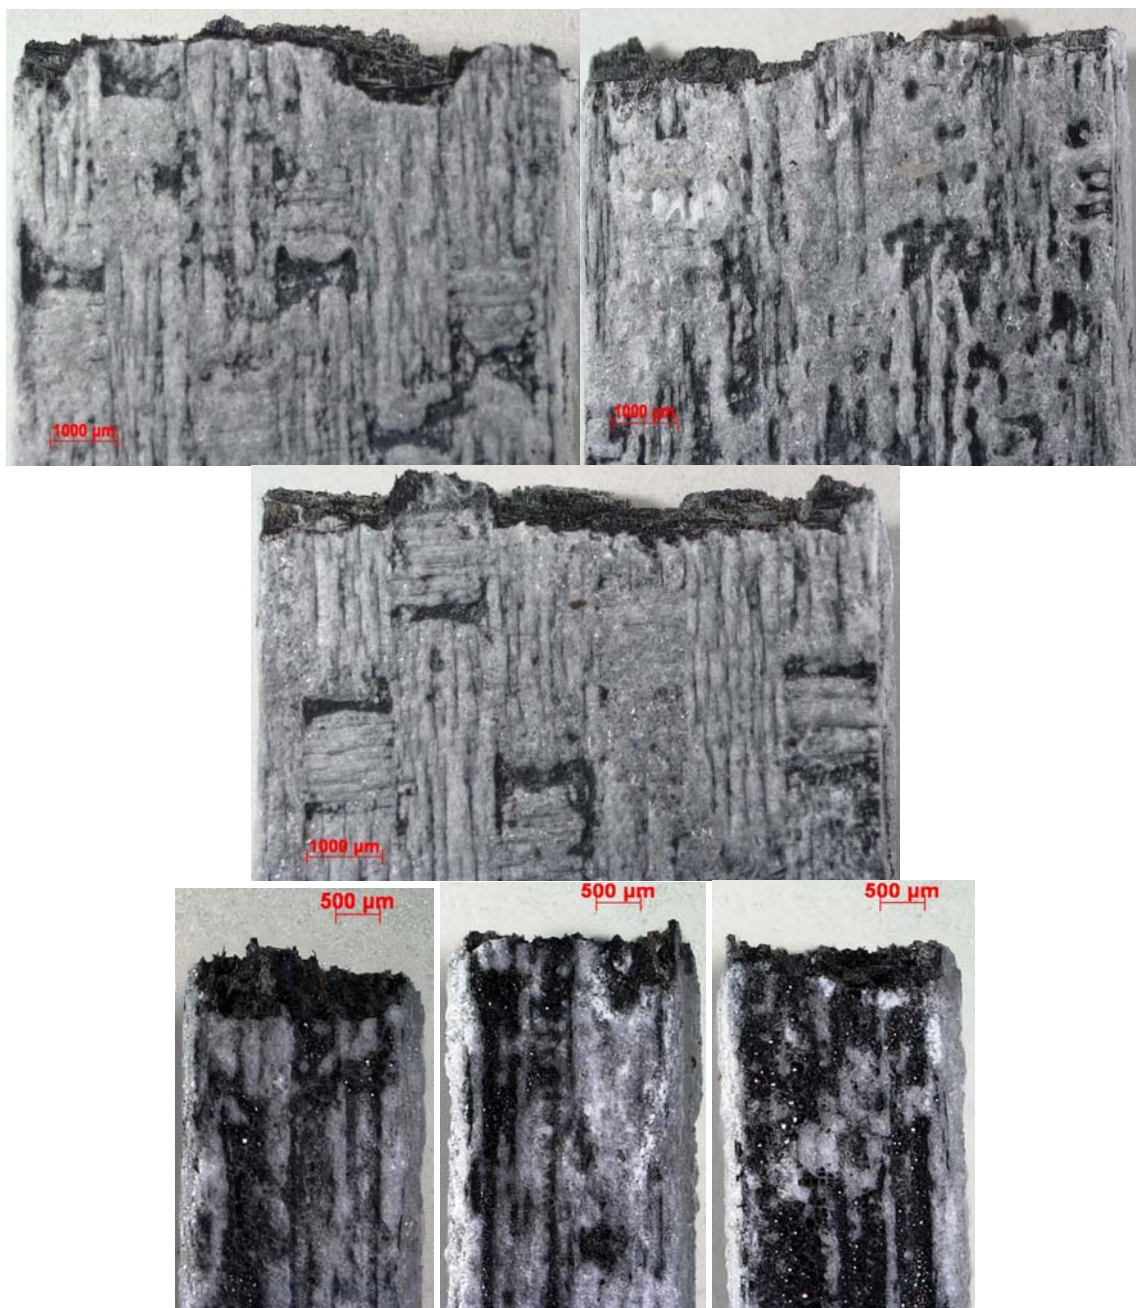
Figure 79. Fracture surface optical micrographs of composite C2 specimen fatigued in steam at 1300 °C with maximum fatigue stress $\sigma_{\max} = 140$ MPa

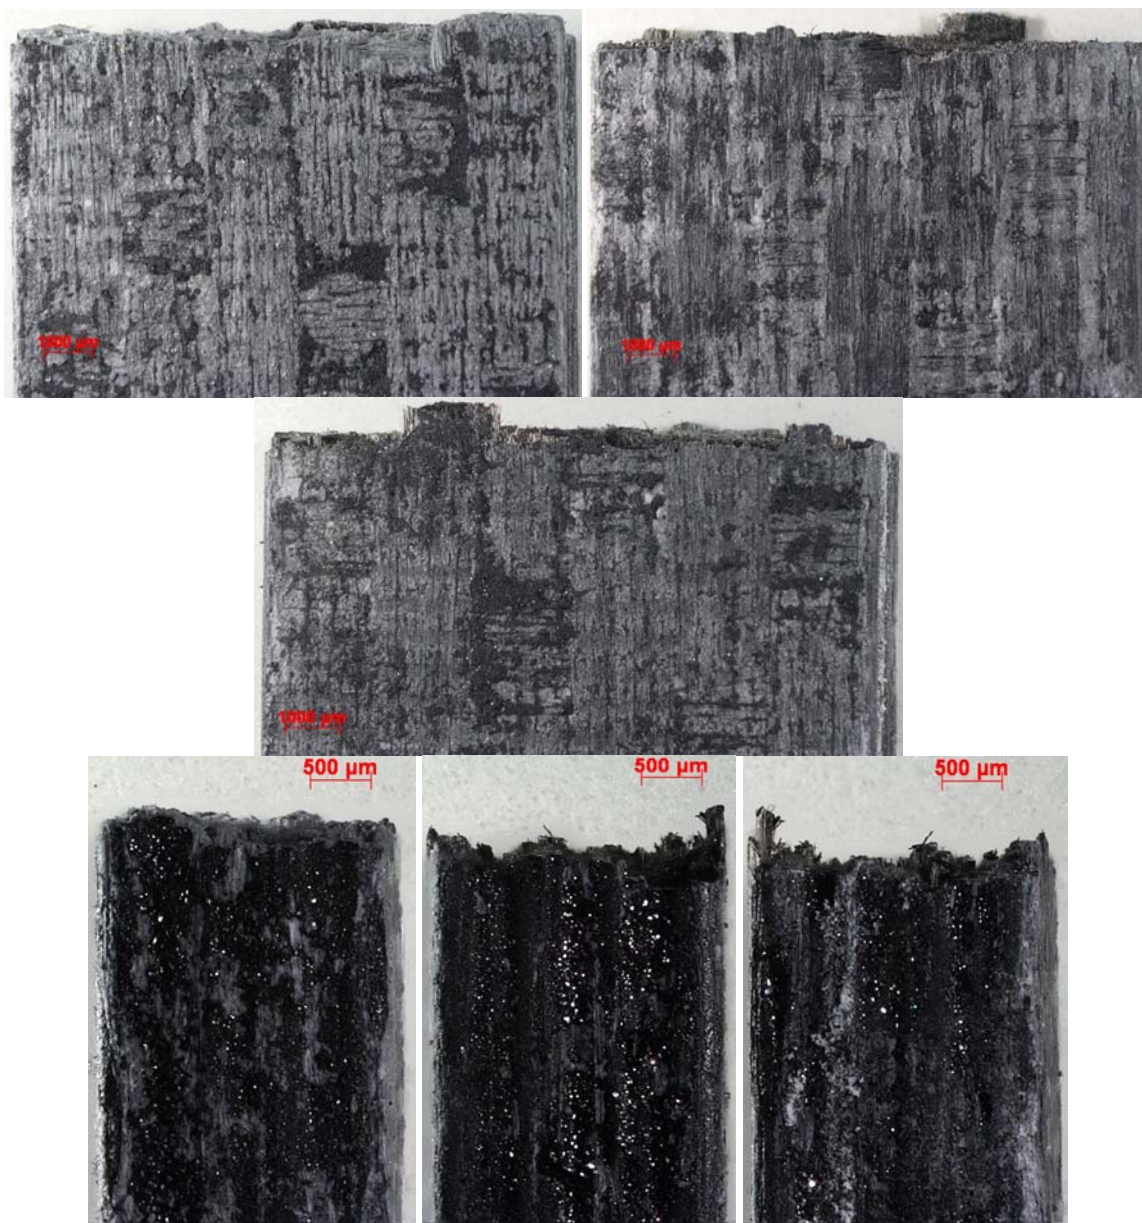
Figure 81. Fracture surface optical micrographs of composite C2 specimen fatigued in steam at 1300 °C with maximum fatigue stress $\sigma_{\max} = 180$ MPa
